## Evidence UI GreenMetric Questionnaire

University : Songkhla Rajabhat University  
Country : Thailand  
Web Address : [www.skru.ac.th](http://www.skru.ac.th)

#### [3.17] Sewage Disposal (WS.6)

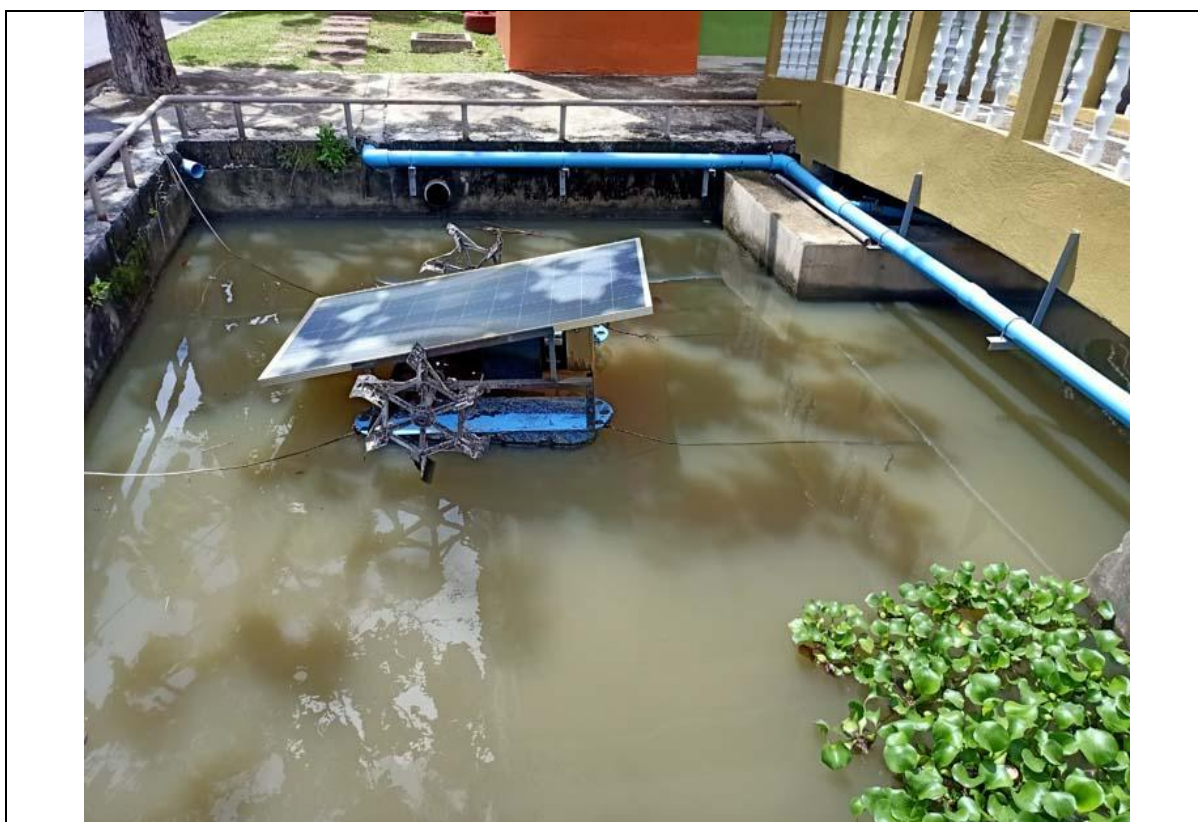
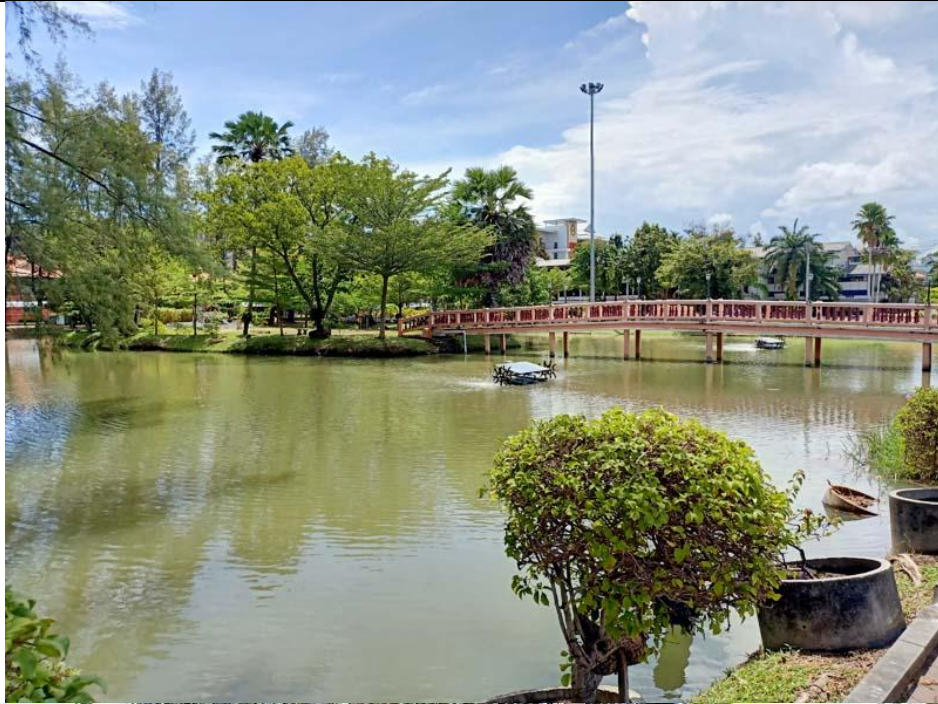
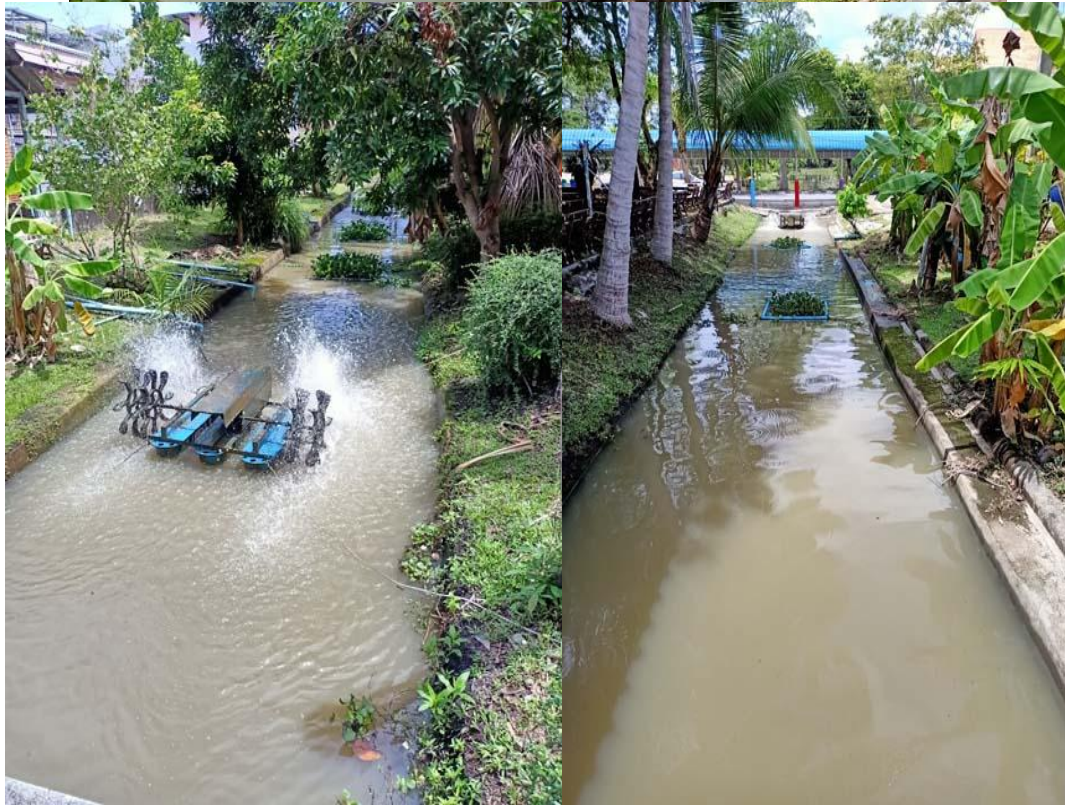
Recycling Program for Songkhla Rajabhat University (Songkhla, Thailand)

The wastewater treatment system of Songkhla Rajabhat University was aeration system which treated technically for reuse wastewater. Songkhla Rajabhat University implements a comprehensive water quality management program to ensure that wastewater and surface water within the campus are effectively monitored and maintained. Regular water quality assessments are conducted at the Environmental Learning Center to evaluate the effectiveness of water treatment processes and to support sustainable environmental management.

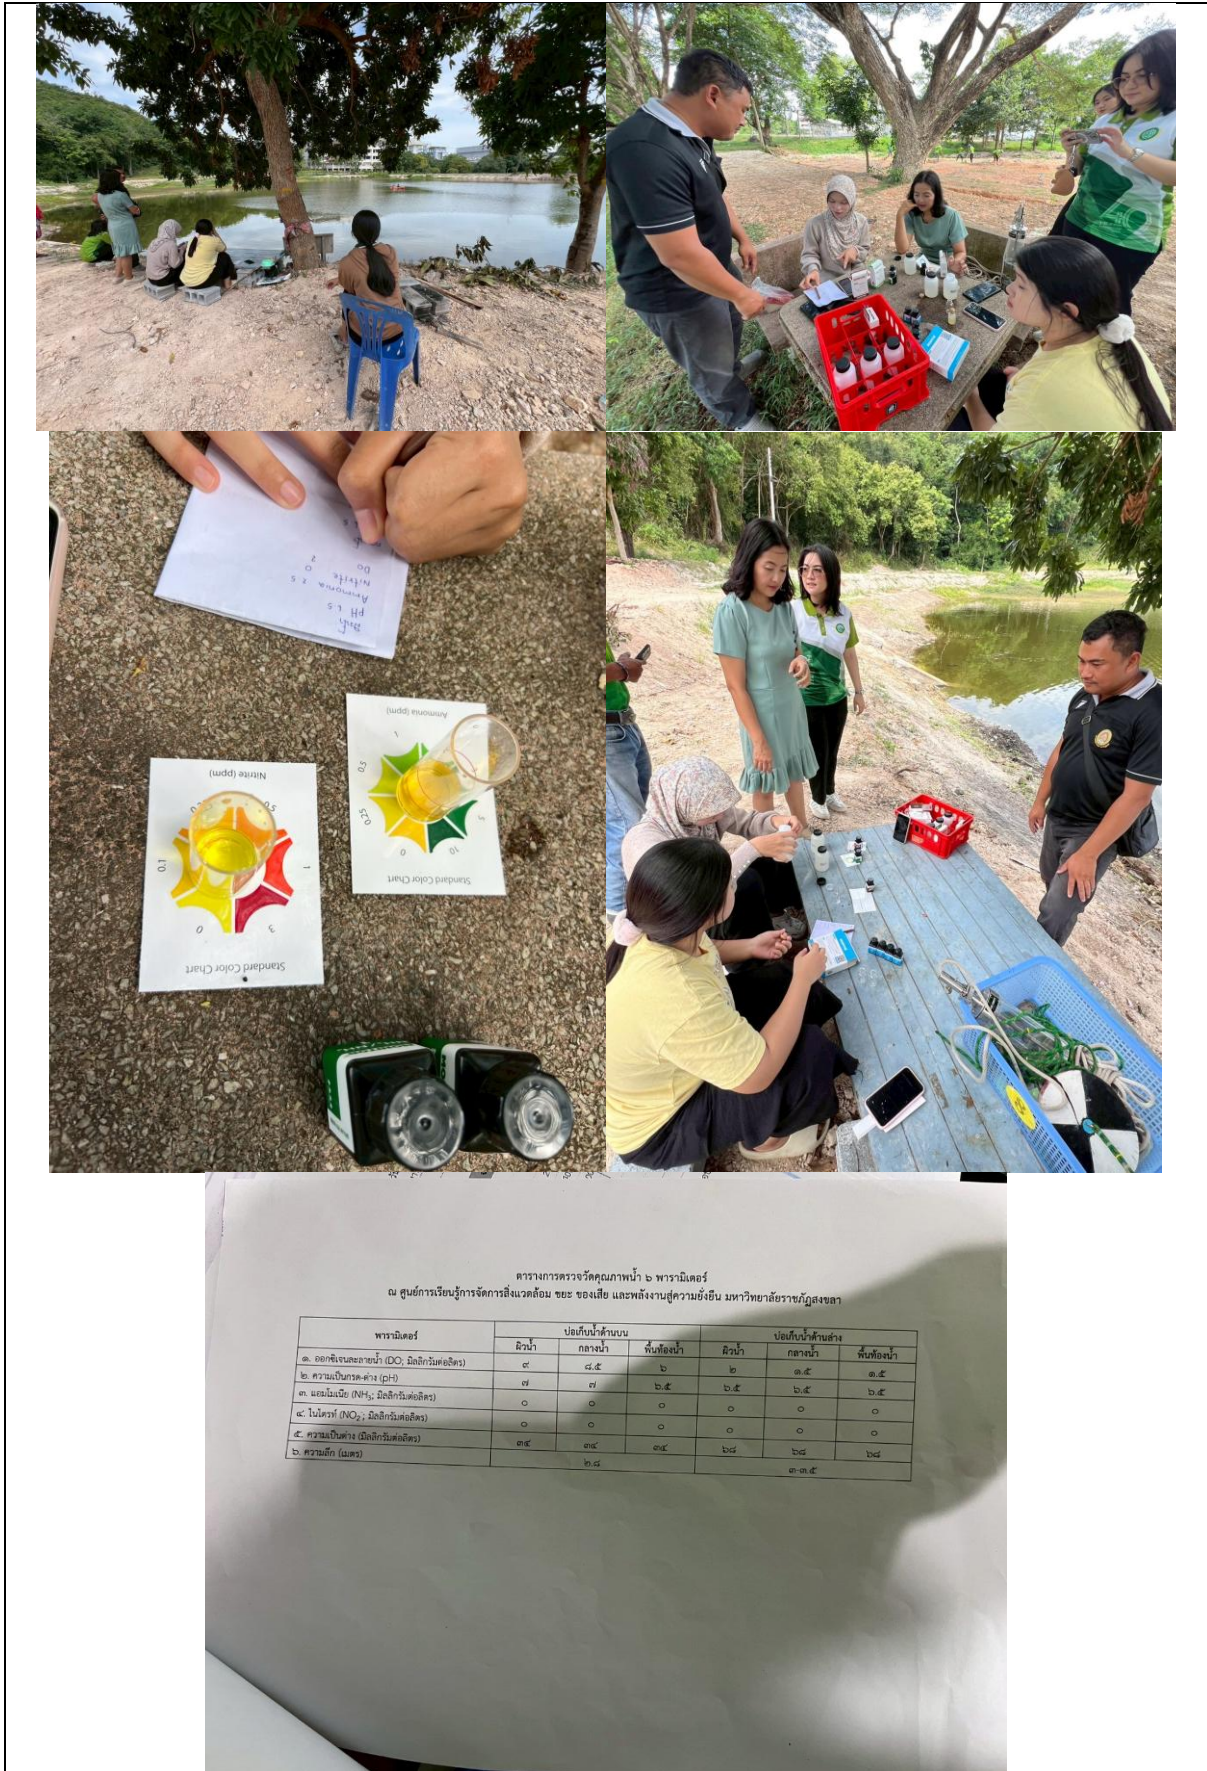
Water quality monitoring at Songkhla Rajabhat University

The university routinely monitors key water quality parameters, including Dissolved Oxygen (DO), pH, Ammonia (NH<sub>3</sub>), Nitrite (NO<sub>2</sub><sup>-</sup>), Salinity, and Water Depth. Water samples are collected from the surface, middle, and bottom layers of the water body to ensure representative monitoring of overall water conditions.

| Parameter | Before Treatment | After Treatment |
| Dissolved Oxygen (DO) | 6.0–9.0 mg/L | 1.5–2.0 mg/L |
| pH | 3.0–6.5 | 6.5 |
| Ammonia (NH <sub>3</sub> ) | 0 mg/L | 0 mg/L |
| Nitrite (NO <sub>2</sub> <sup>-</sup> ) | 0 mg/L | 0 mg/L |
| Salinity | 35 ppt | 28 ppt |
| Water Depth | 2.8 m | 3.0–3.5 m |
